# THE VANGUARD SATELLITE LAUNCHING VEHICLE - AN ENGINEERING SUMMARY \*

(Engineering Report No. 11022)

April 1960

THE MARTIN COMPANY, Baltimore, Md.

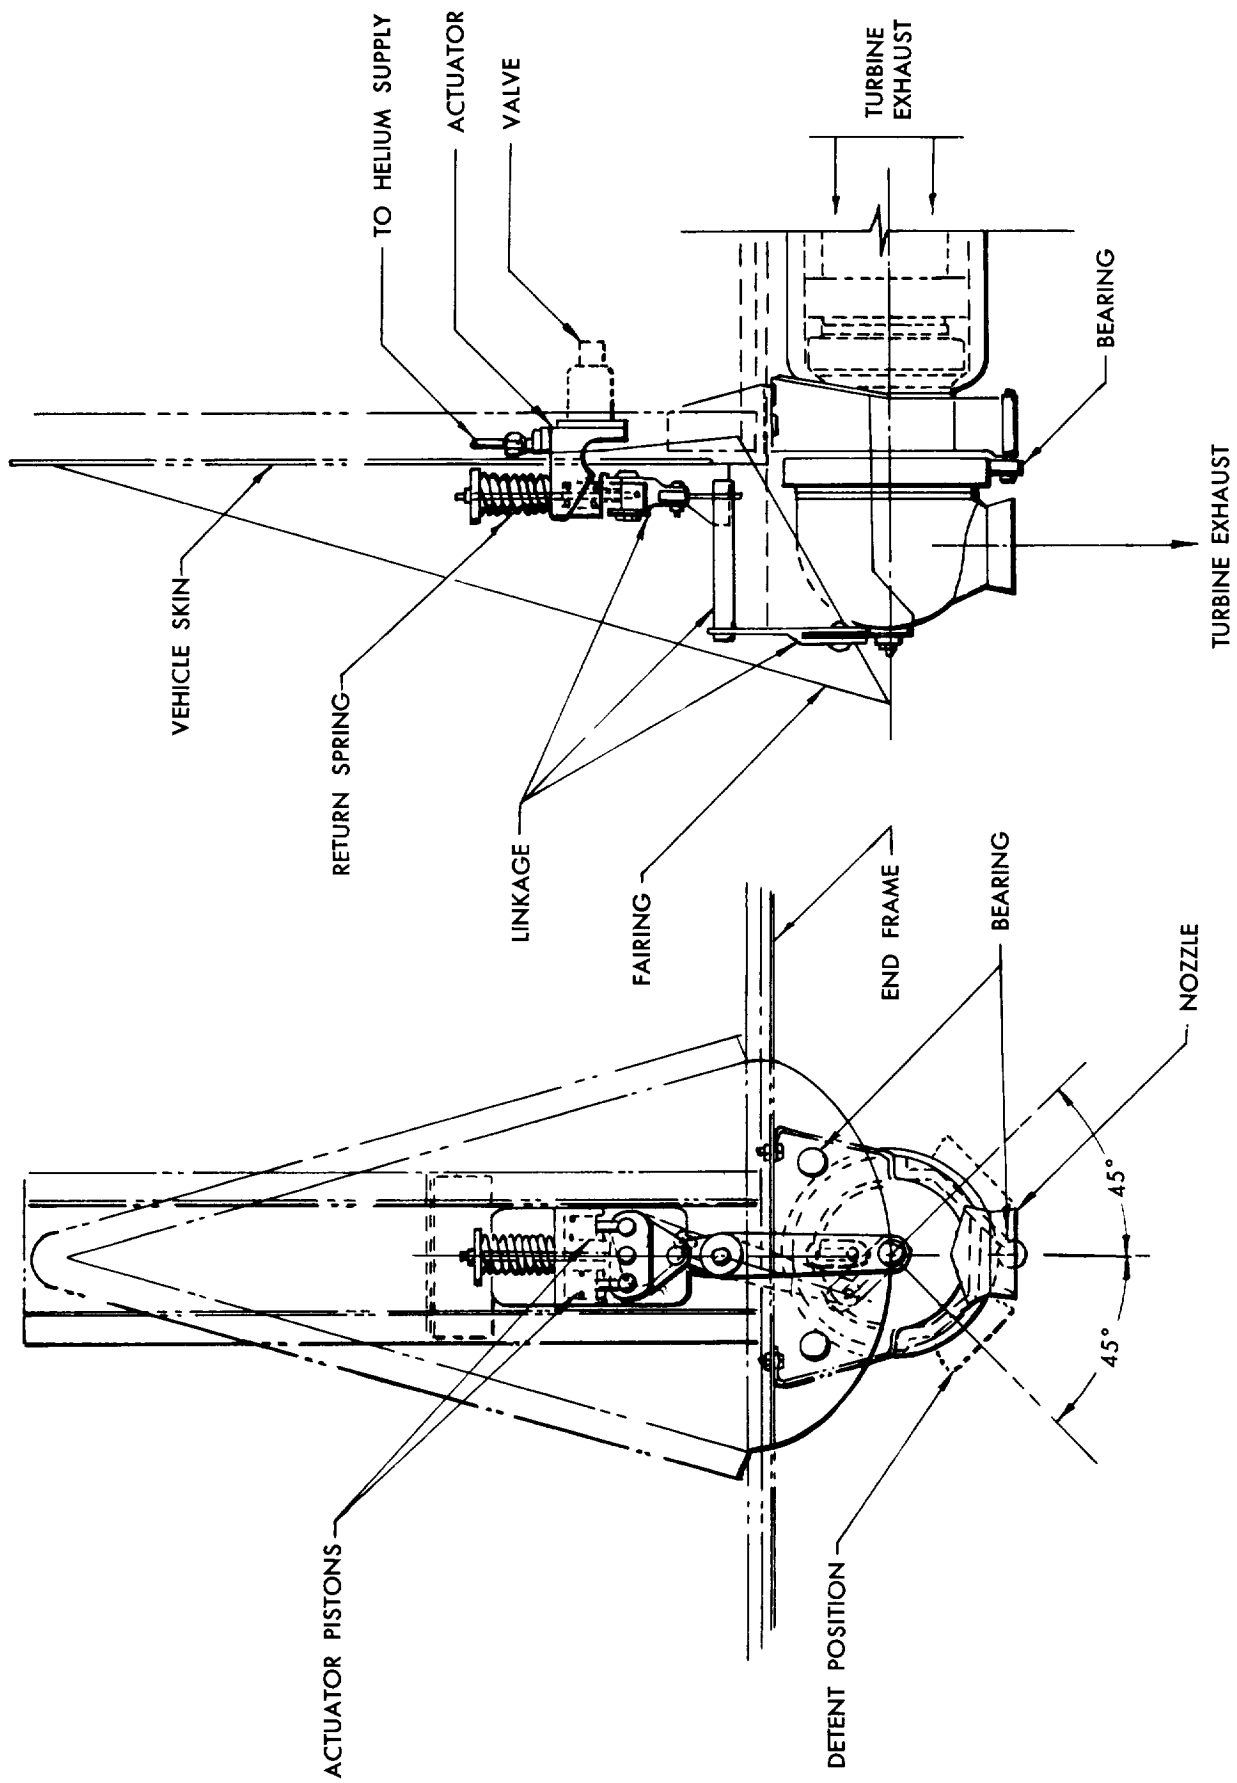
Fig. 32 First-Stage Roll Jet Actuation Mechanism

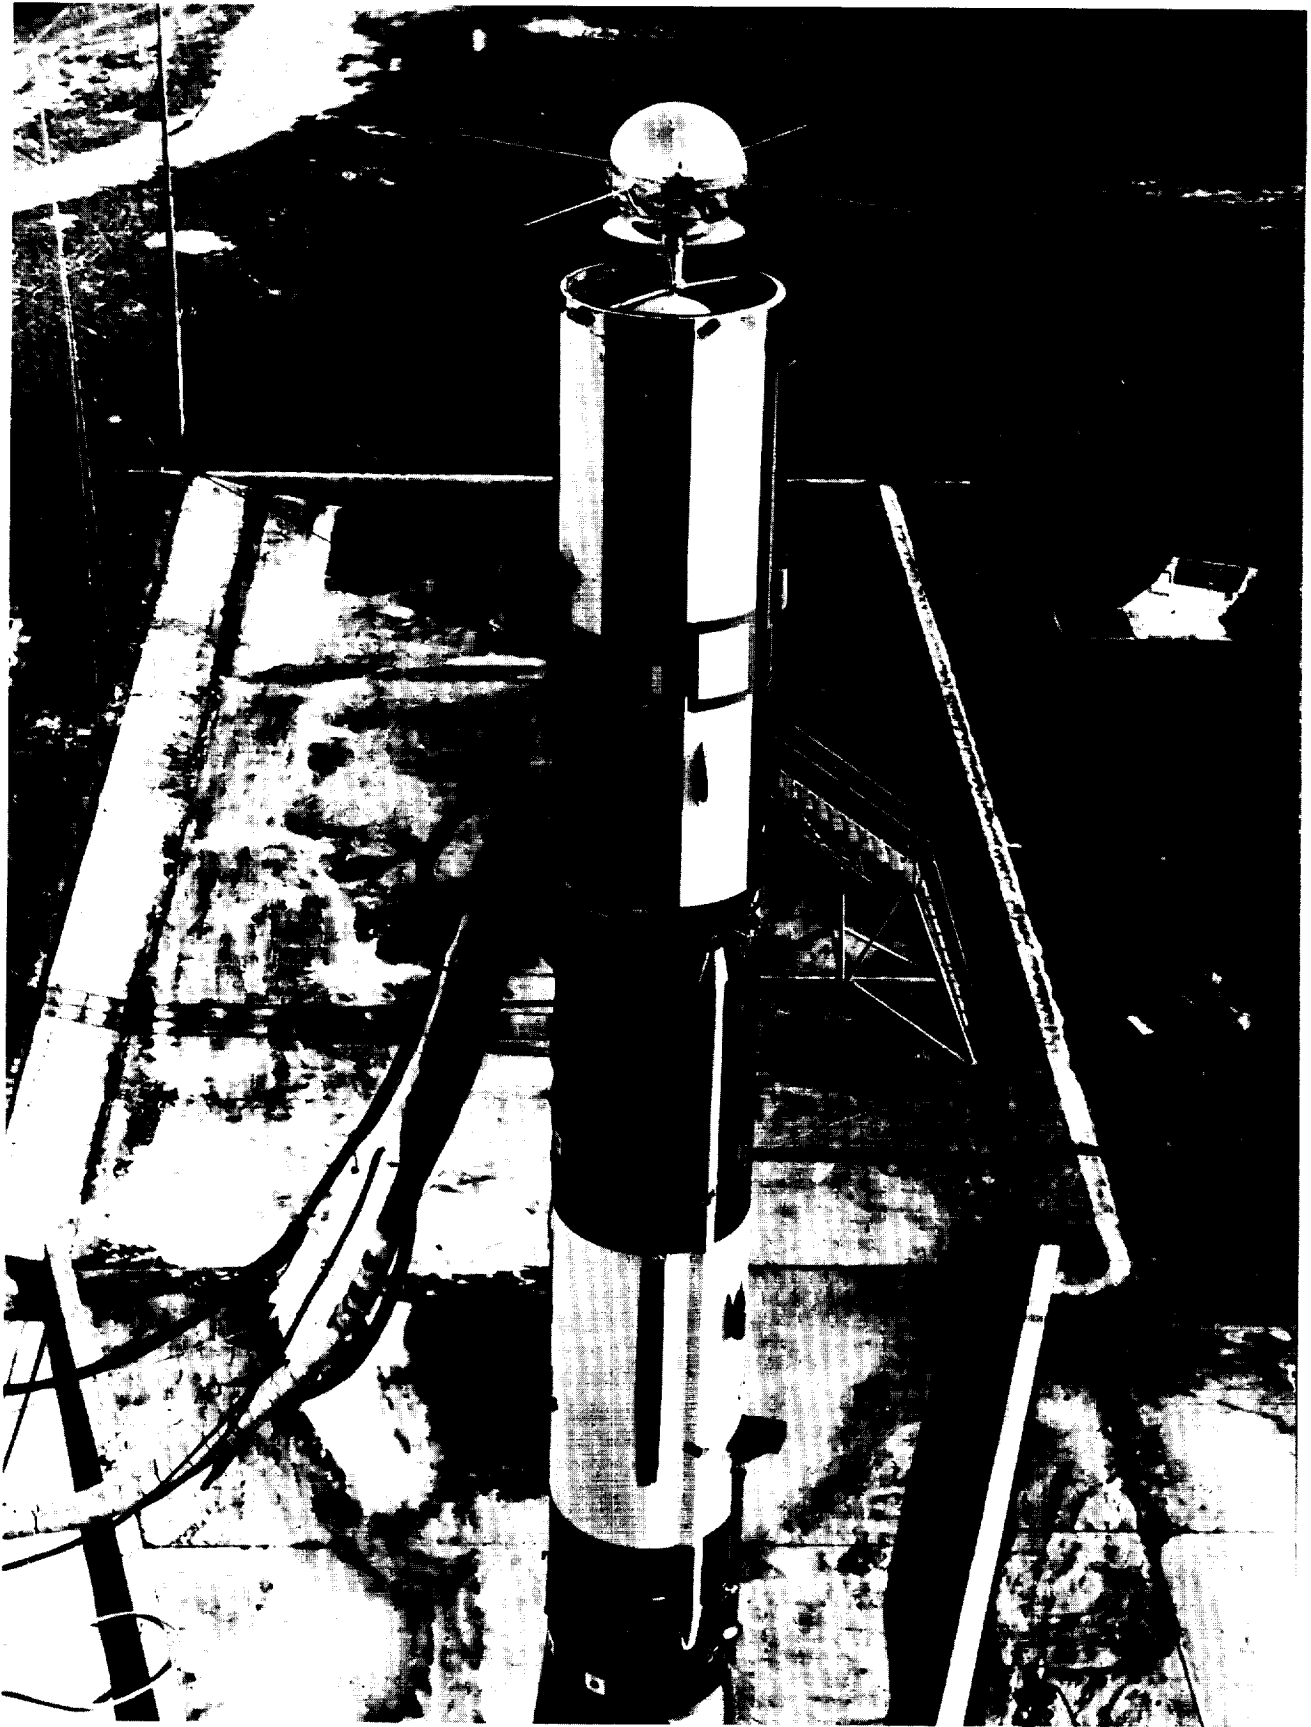
Fig. 35 SLV-4 Satellite

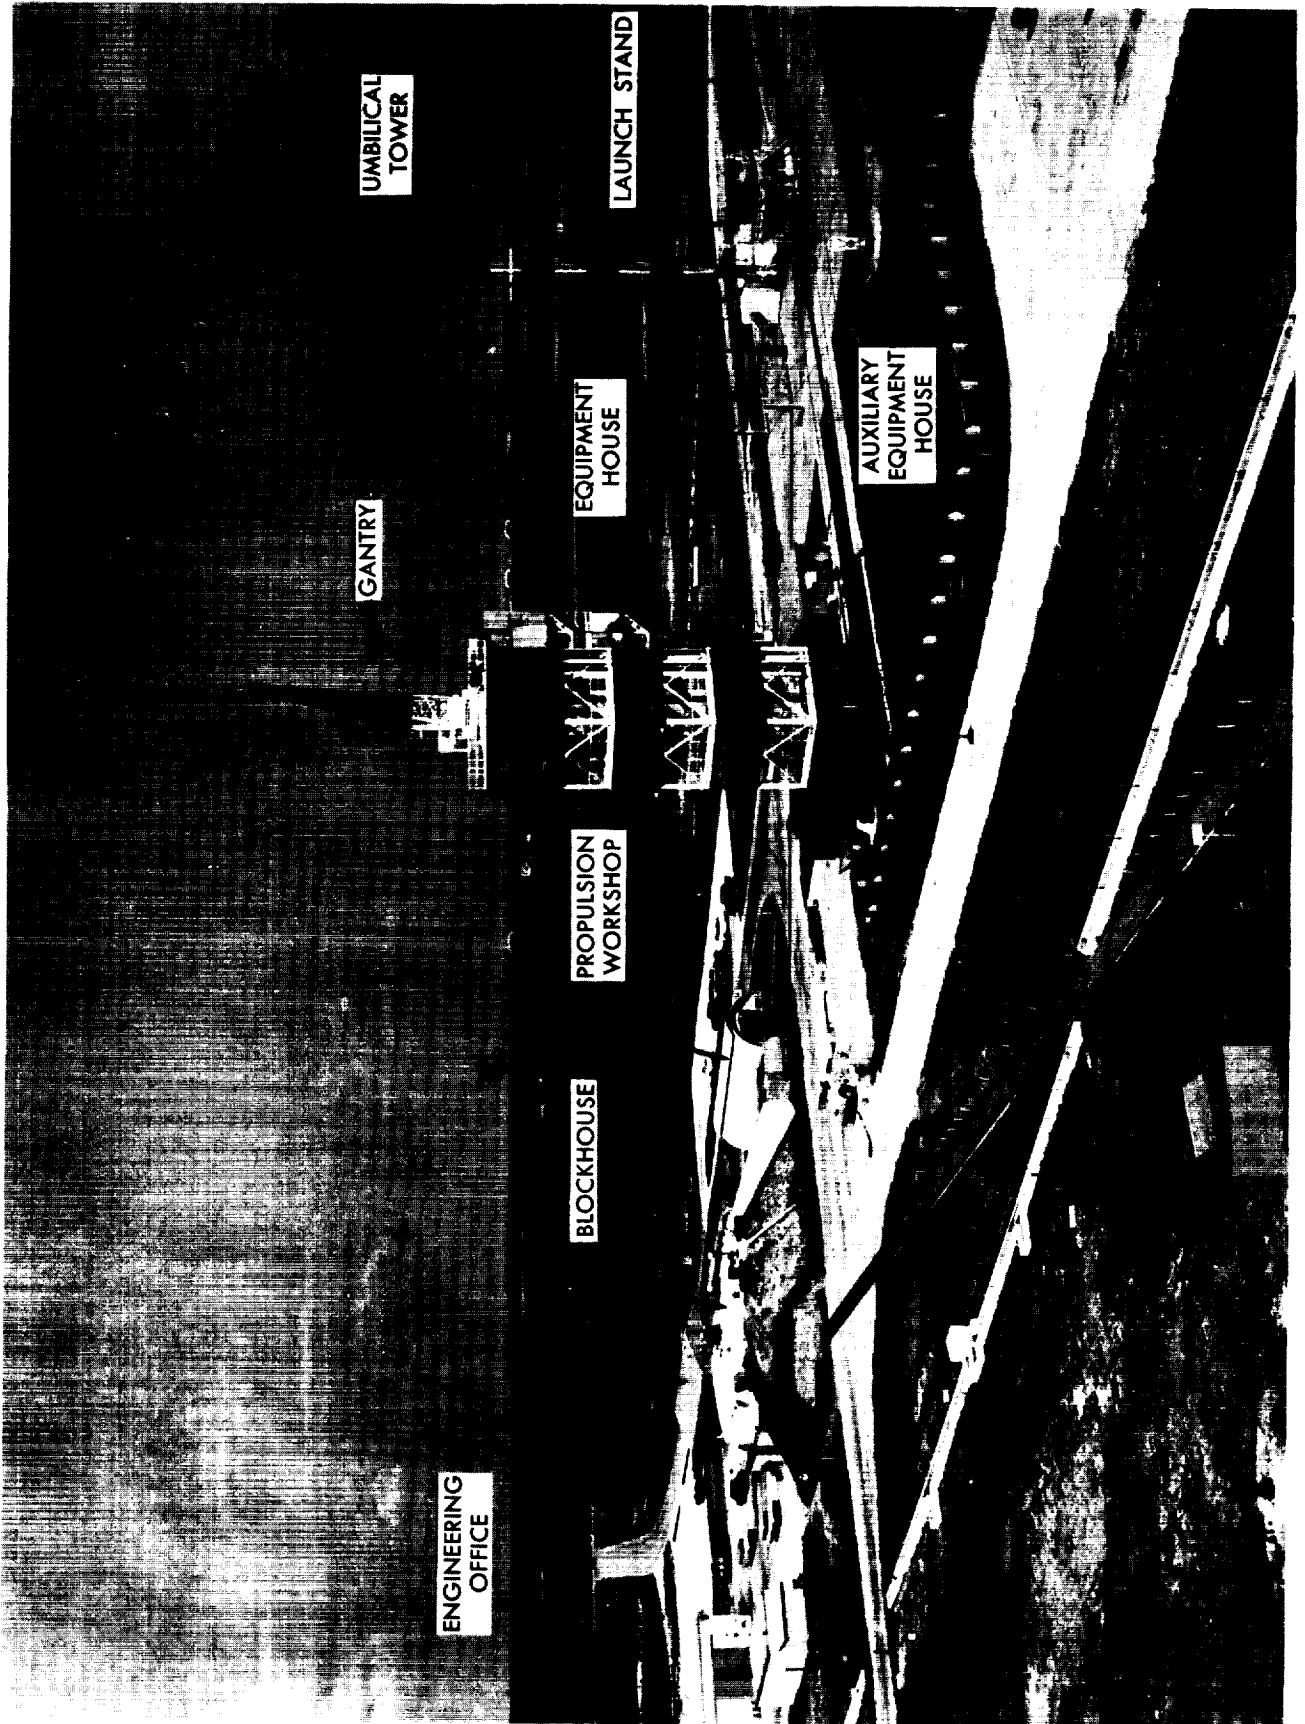
Fig. 38 Vanguard Launch Complex

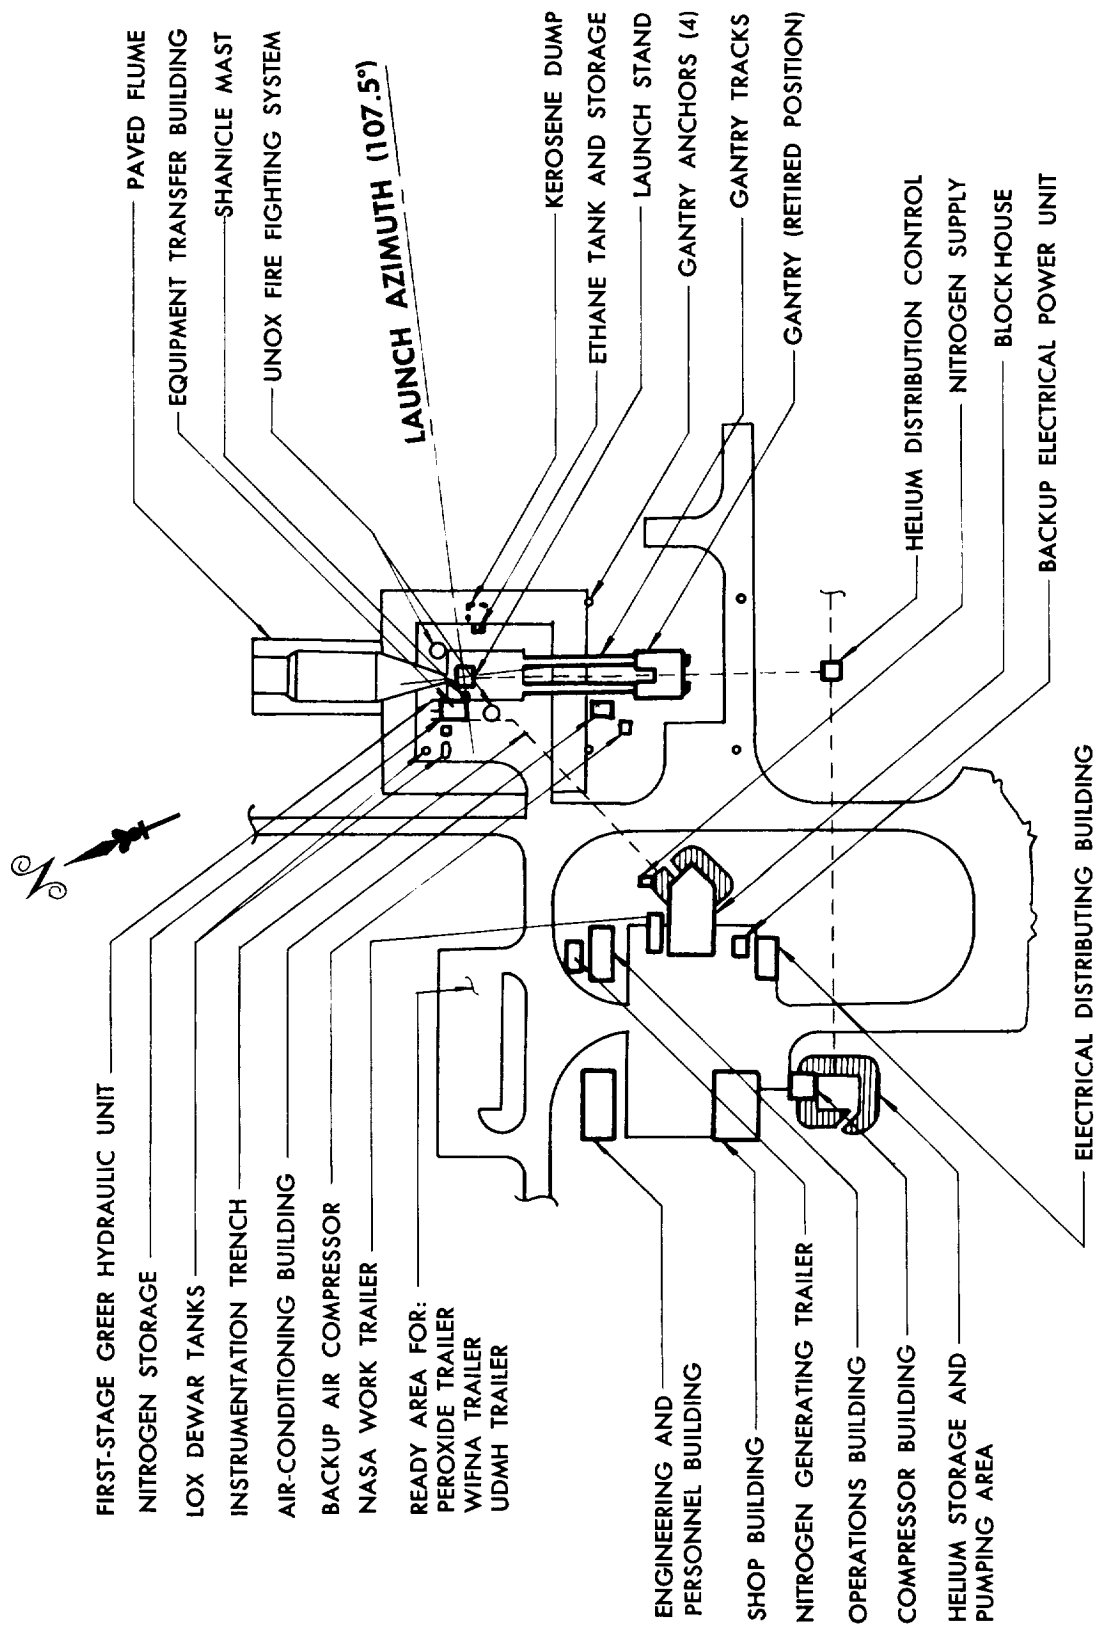
Fig. 39 Vanguard Launch Area Schematic (AMR Launch Complex No. 18A)

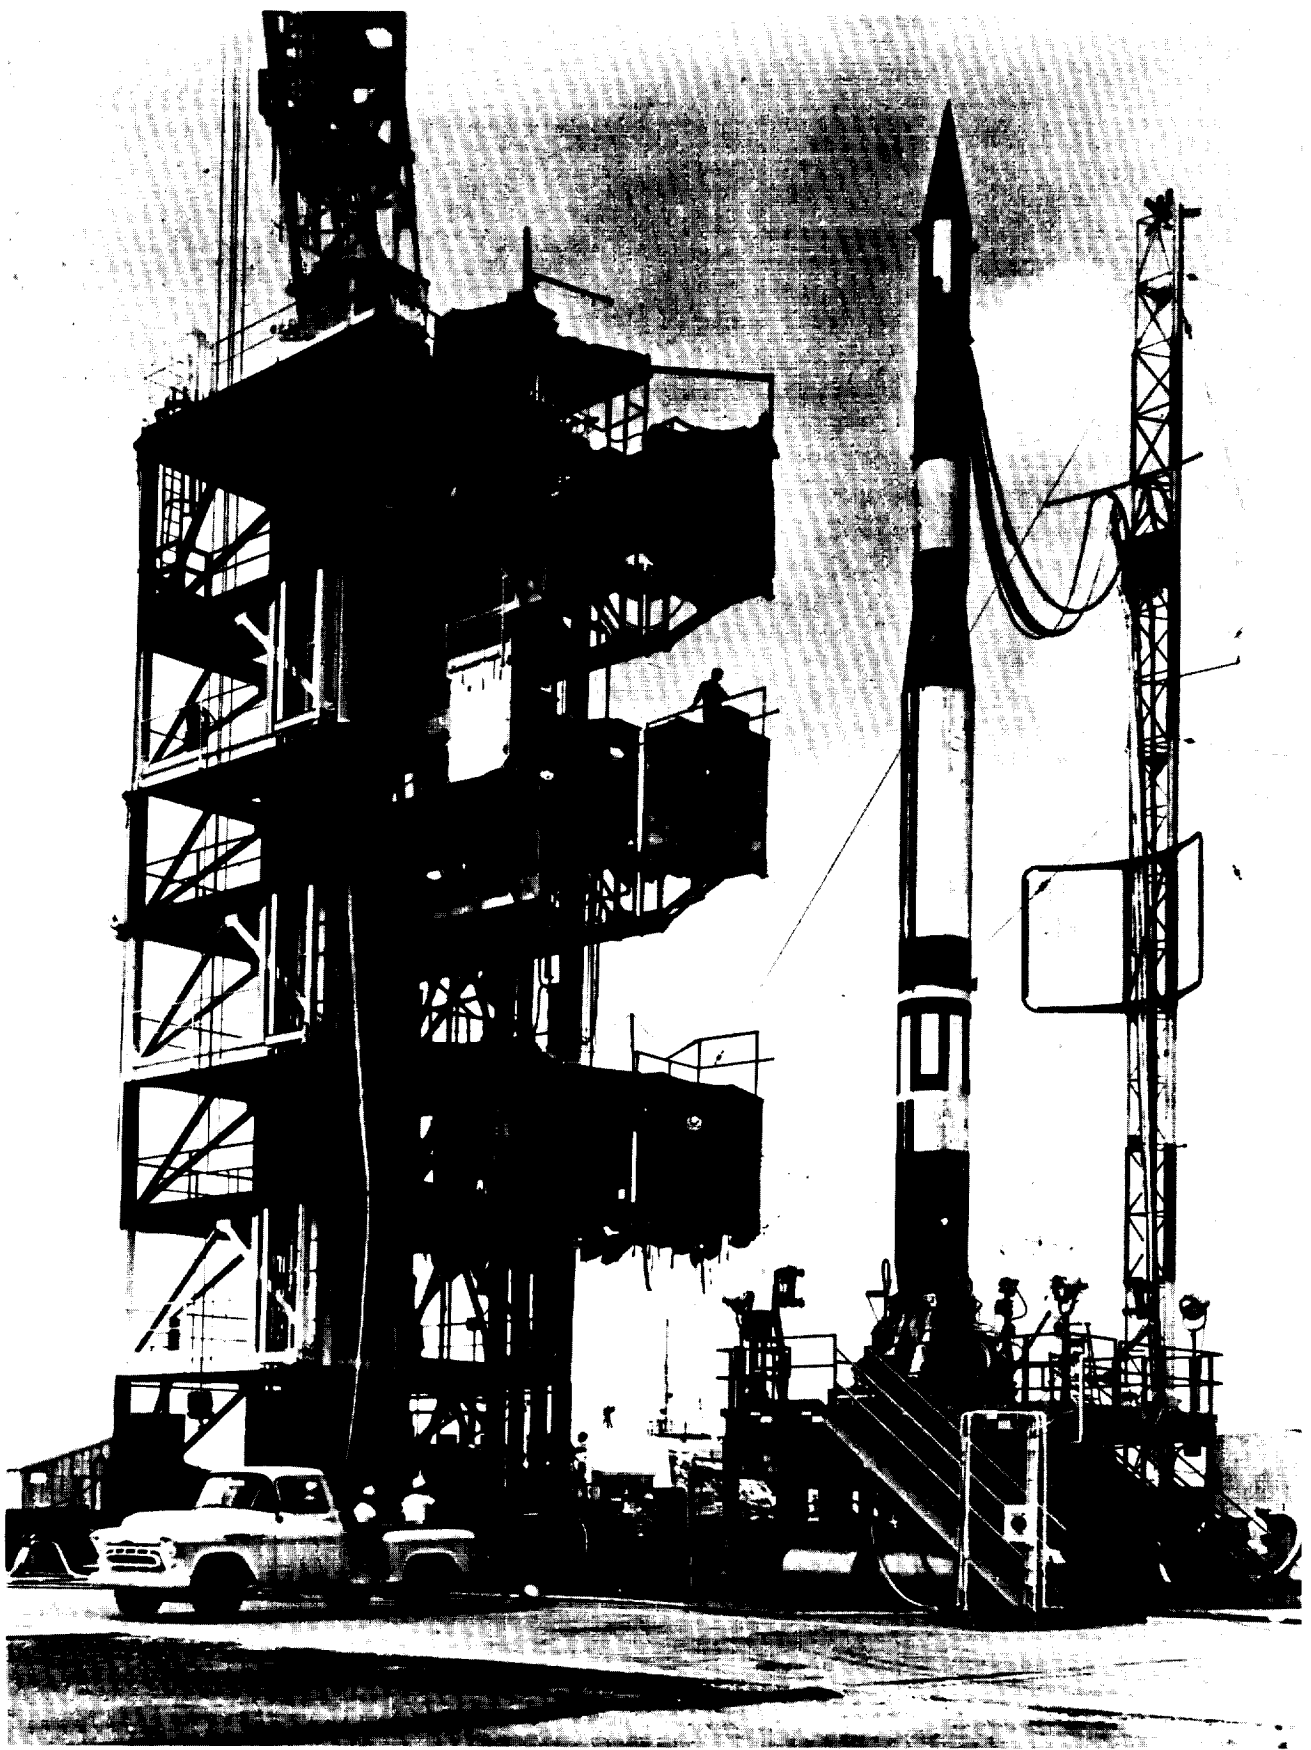
**Fig. 40 Vanguard Vehicle During Prelaunch Operations**

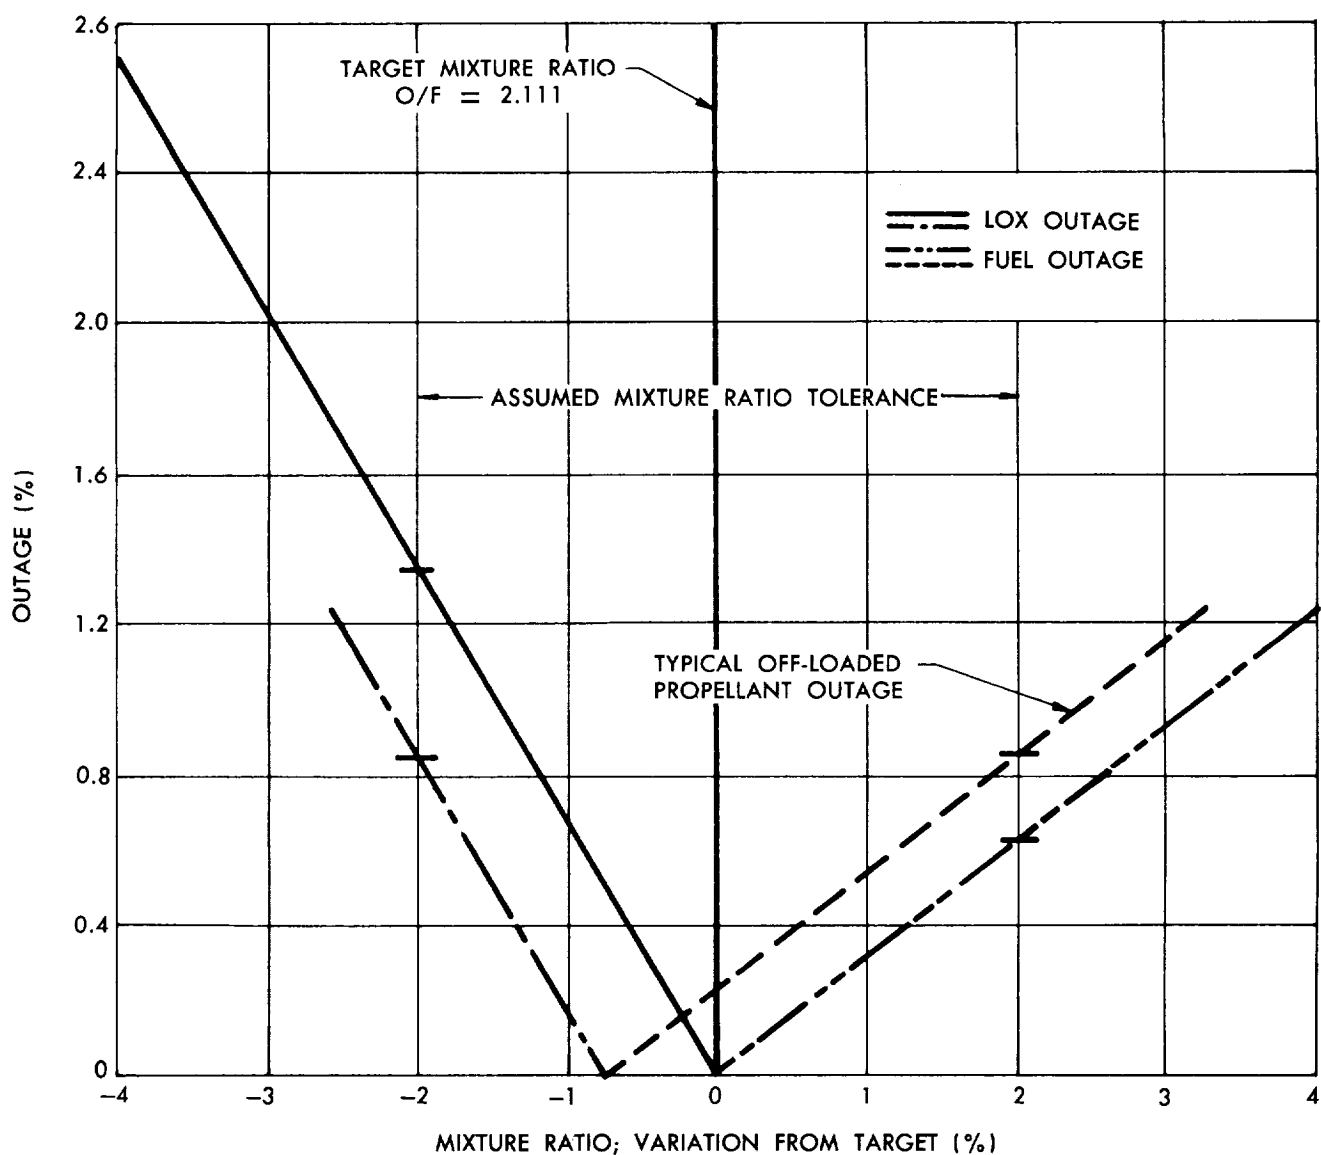
Fig. 42 Variation of Outage with First-Stage Mixture Ratio

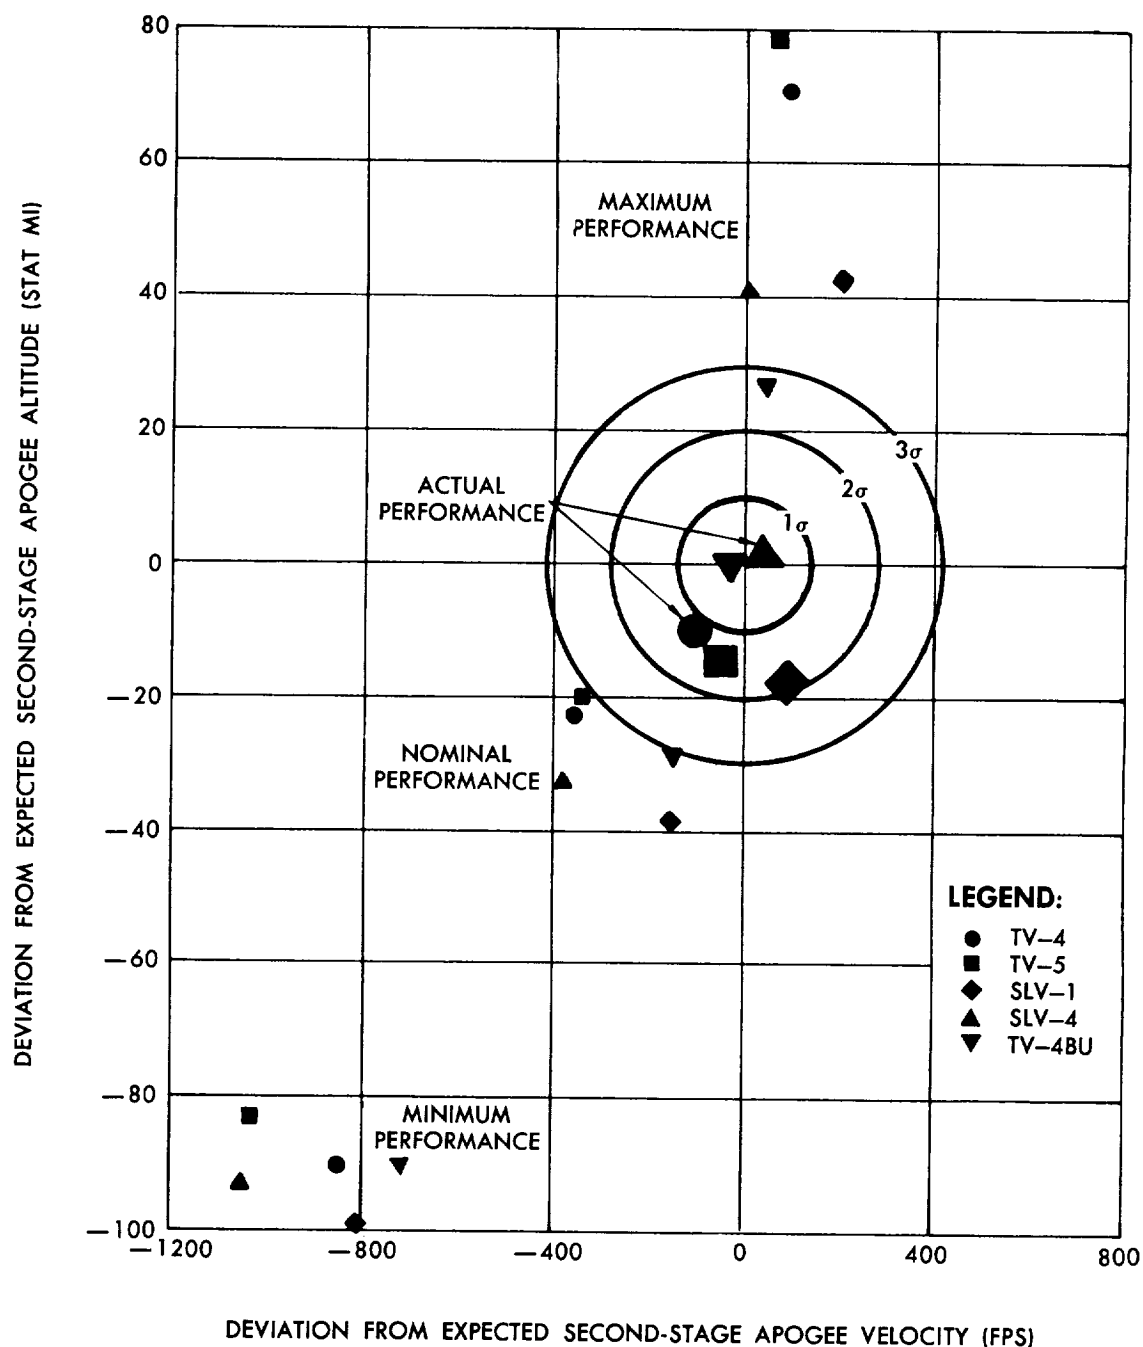
Fig. 43 Comparison of Predicted and Actual Second-Stage Apogee with Expected Vanguard Performance

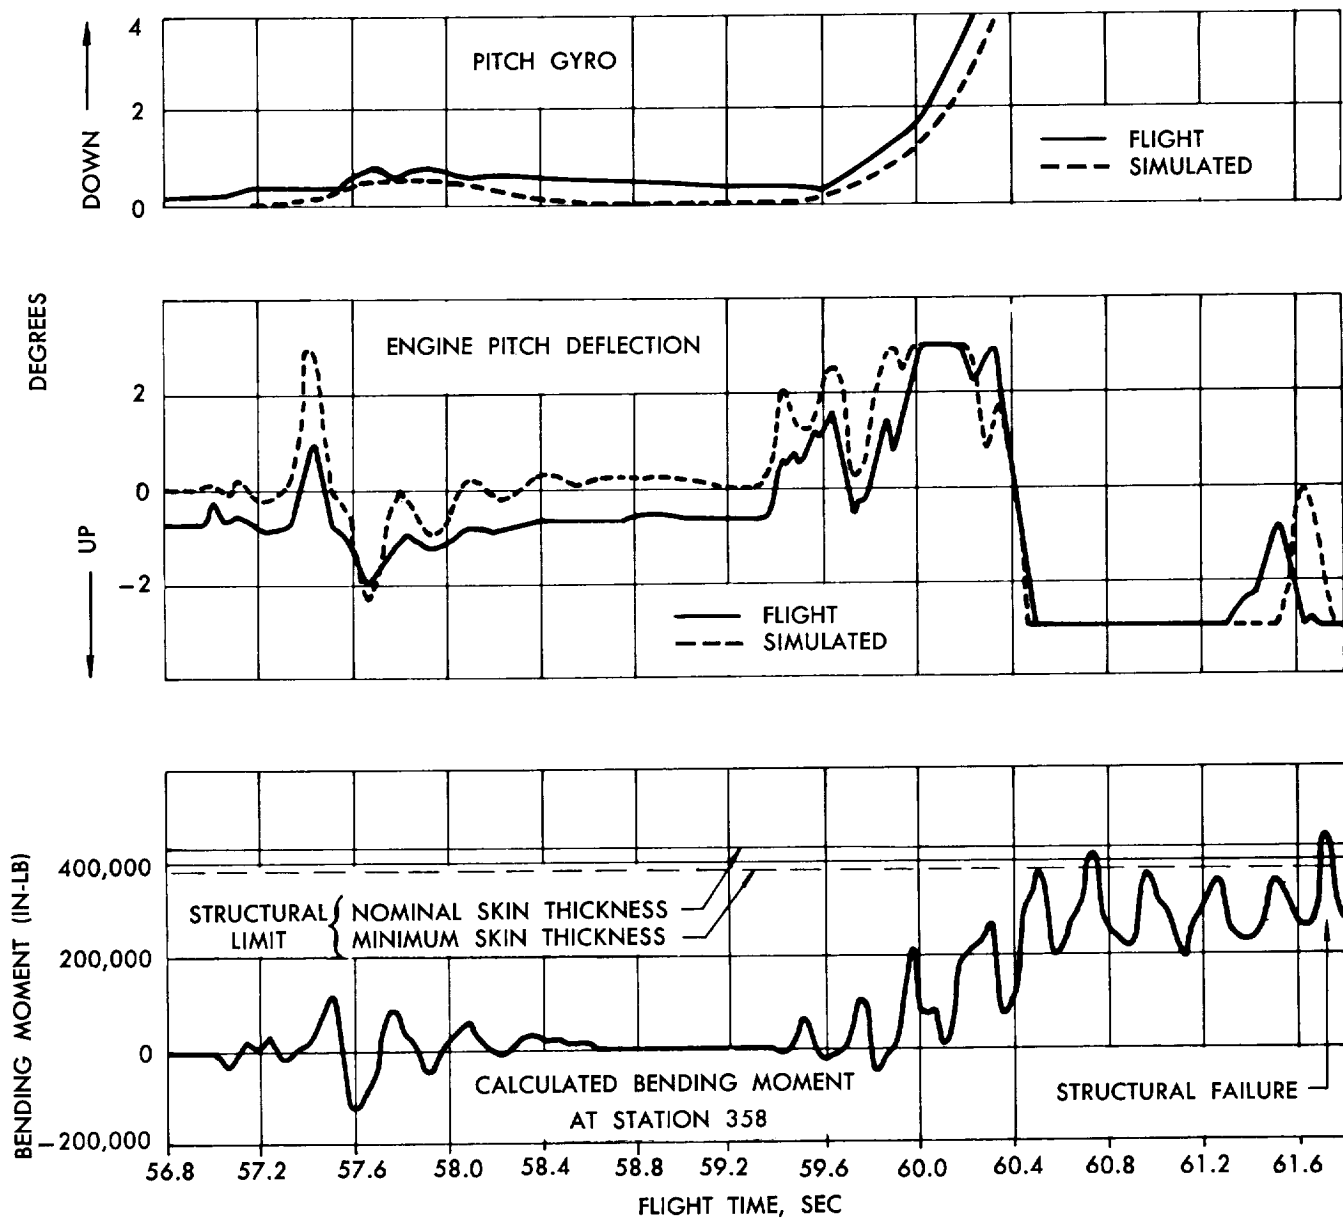
Fig. 44 Time Histories of Vehicle Bending Moment Resulting from Abnormal Engine Pitch Motions, TV-3BU

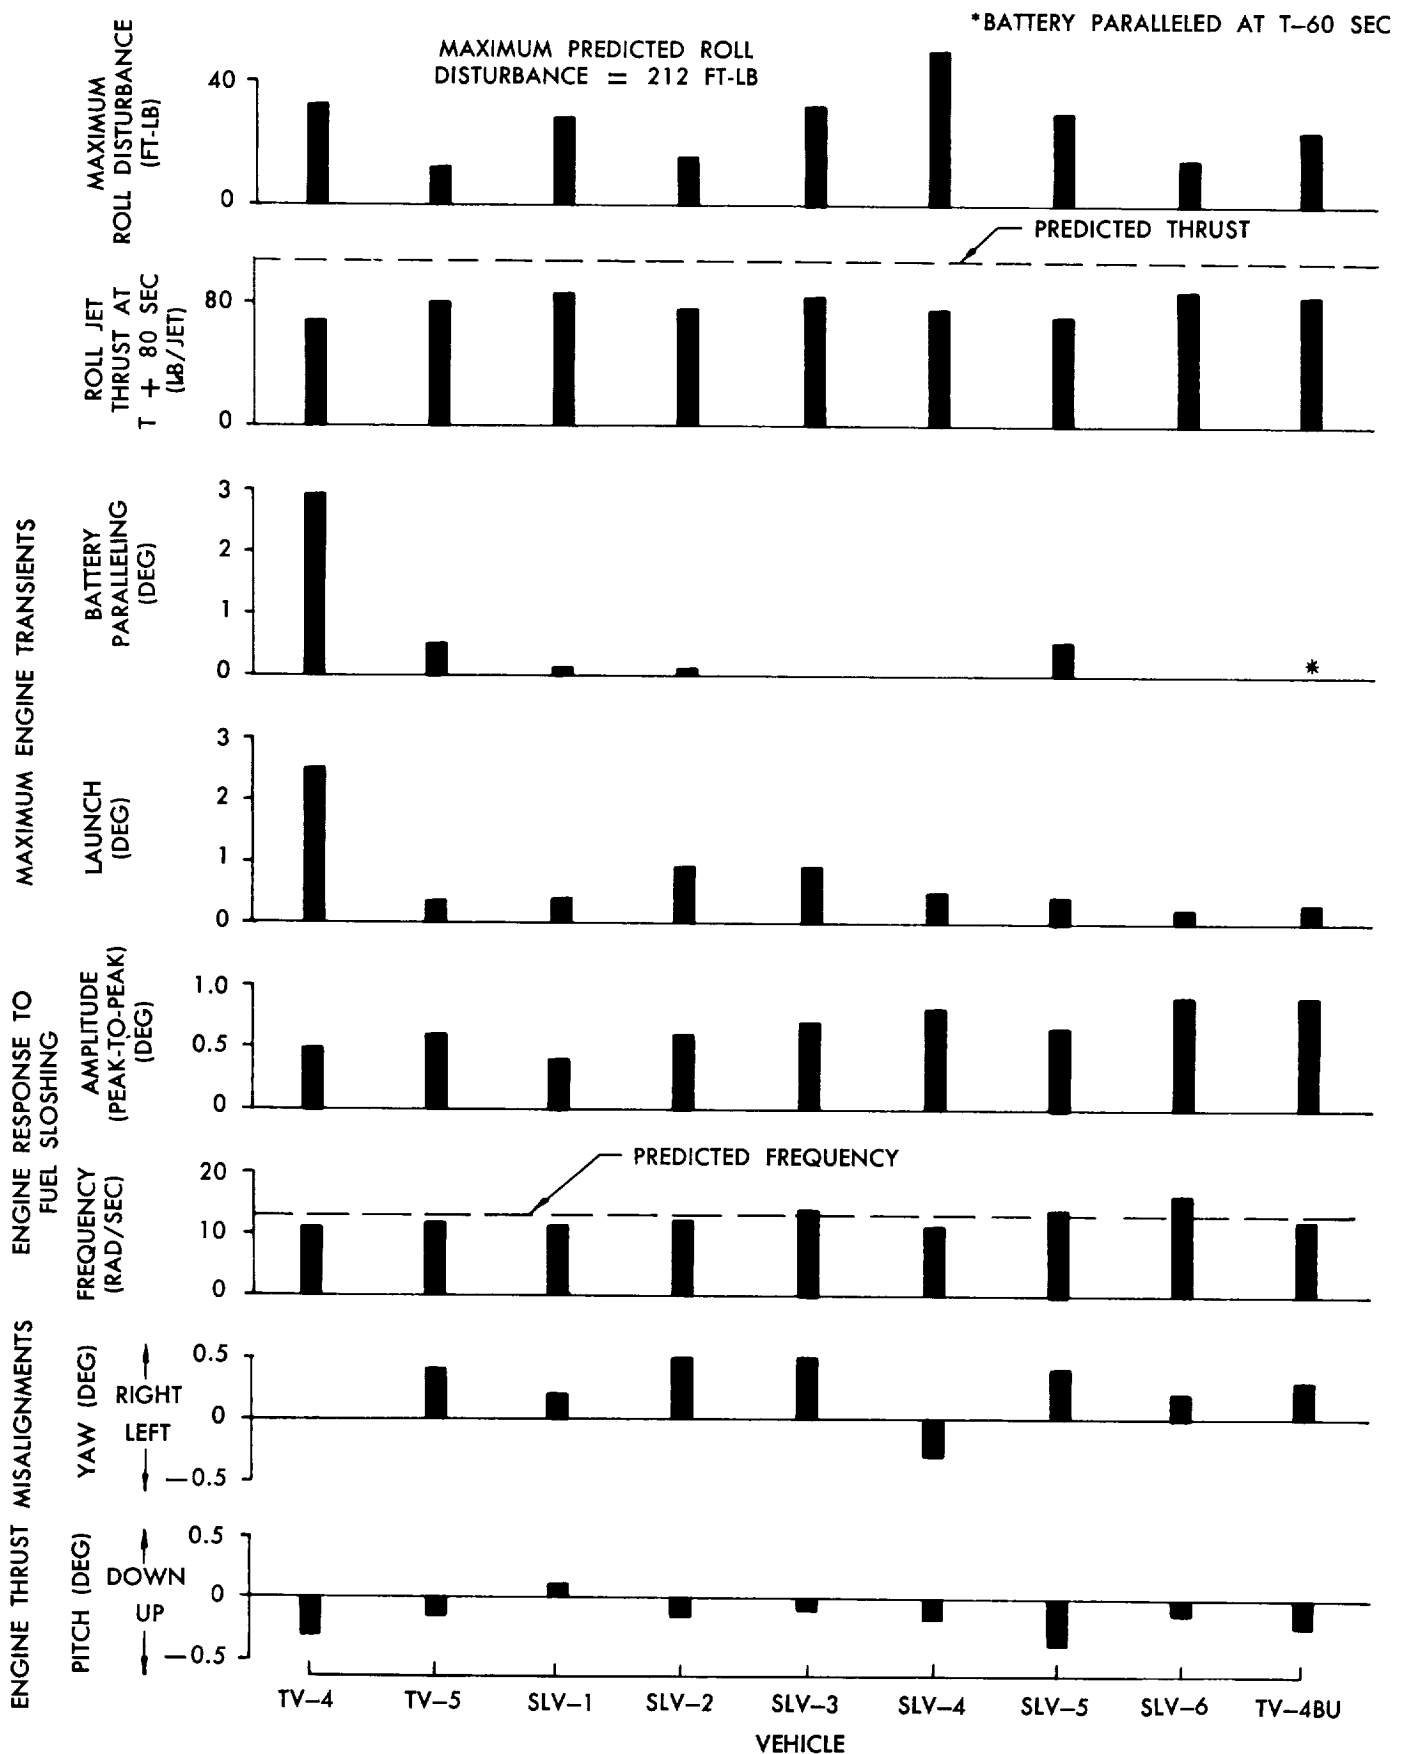
Fig. 45 First-Stage Controls Performance

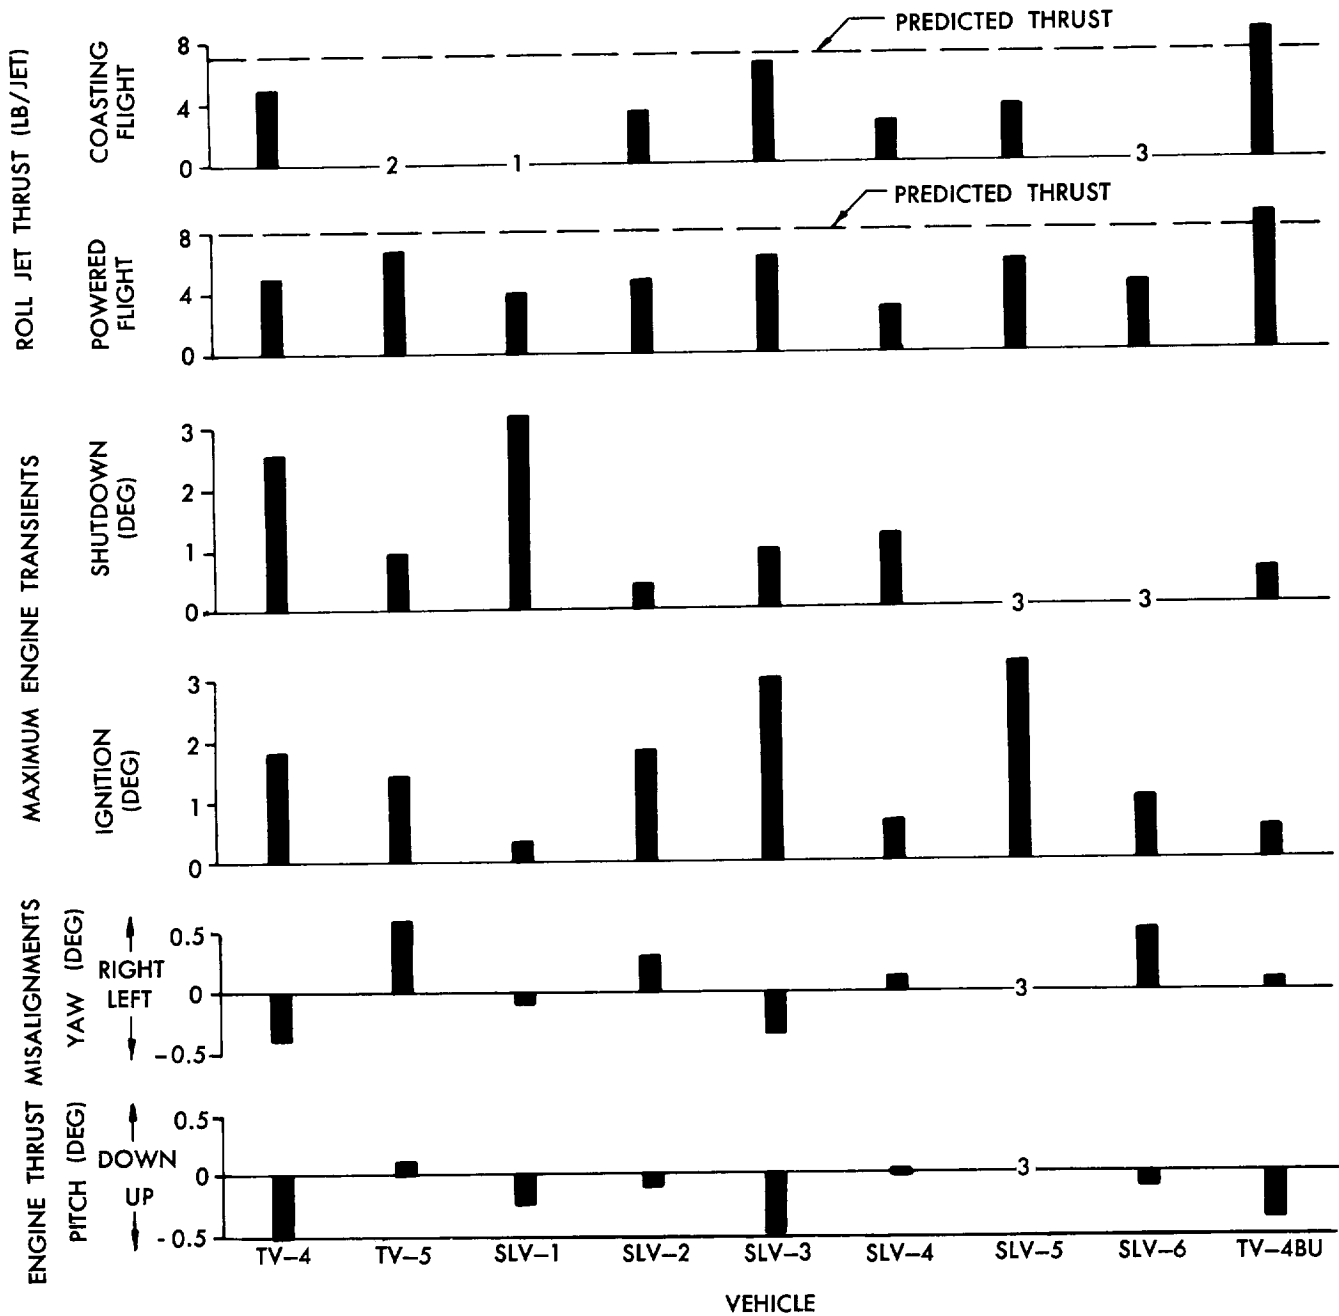
Fig. 46 Second-Stage Controls Performance

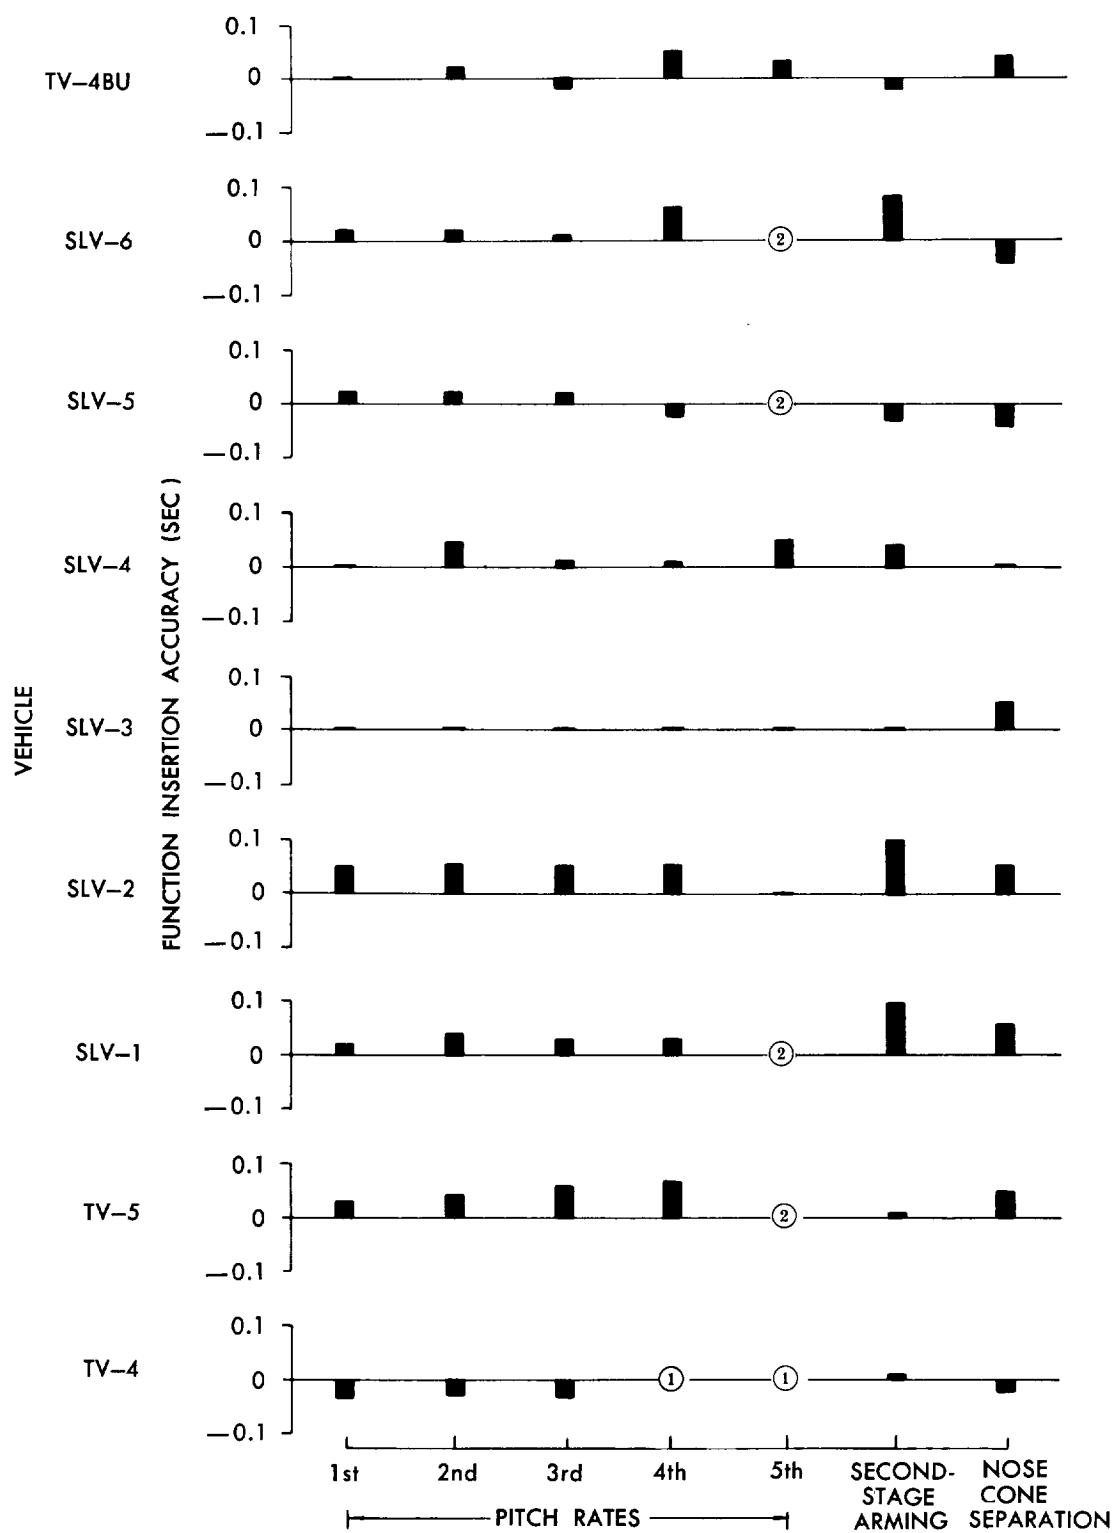
Fig. 47 Program Timer Operation
